ARA-ES-00-0335

AIRFIELD ENGINEERING ASSESSMENT AND PAVEMENT CONDITION SURVEY

EXECUTIVE SUMMARY

KEESLER AIR FORCE BASE, MISSISSIPPI

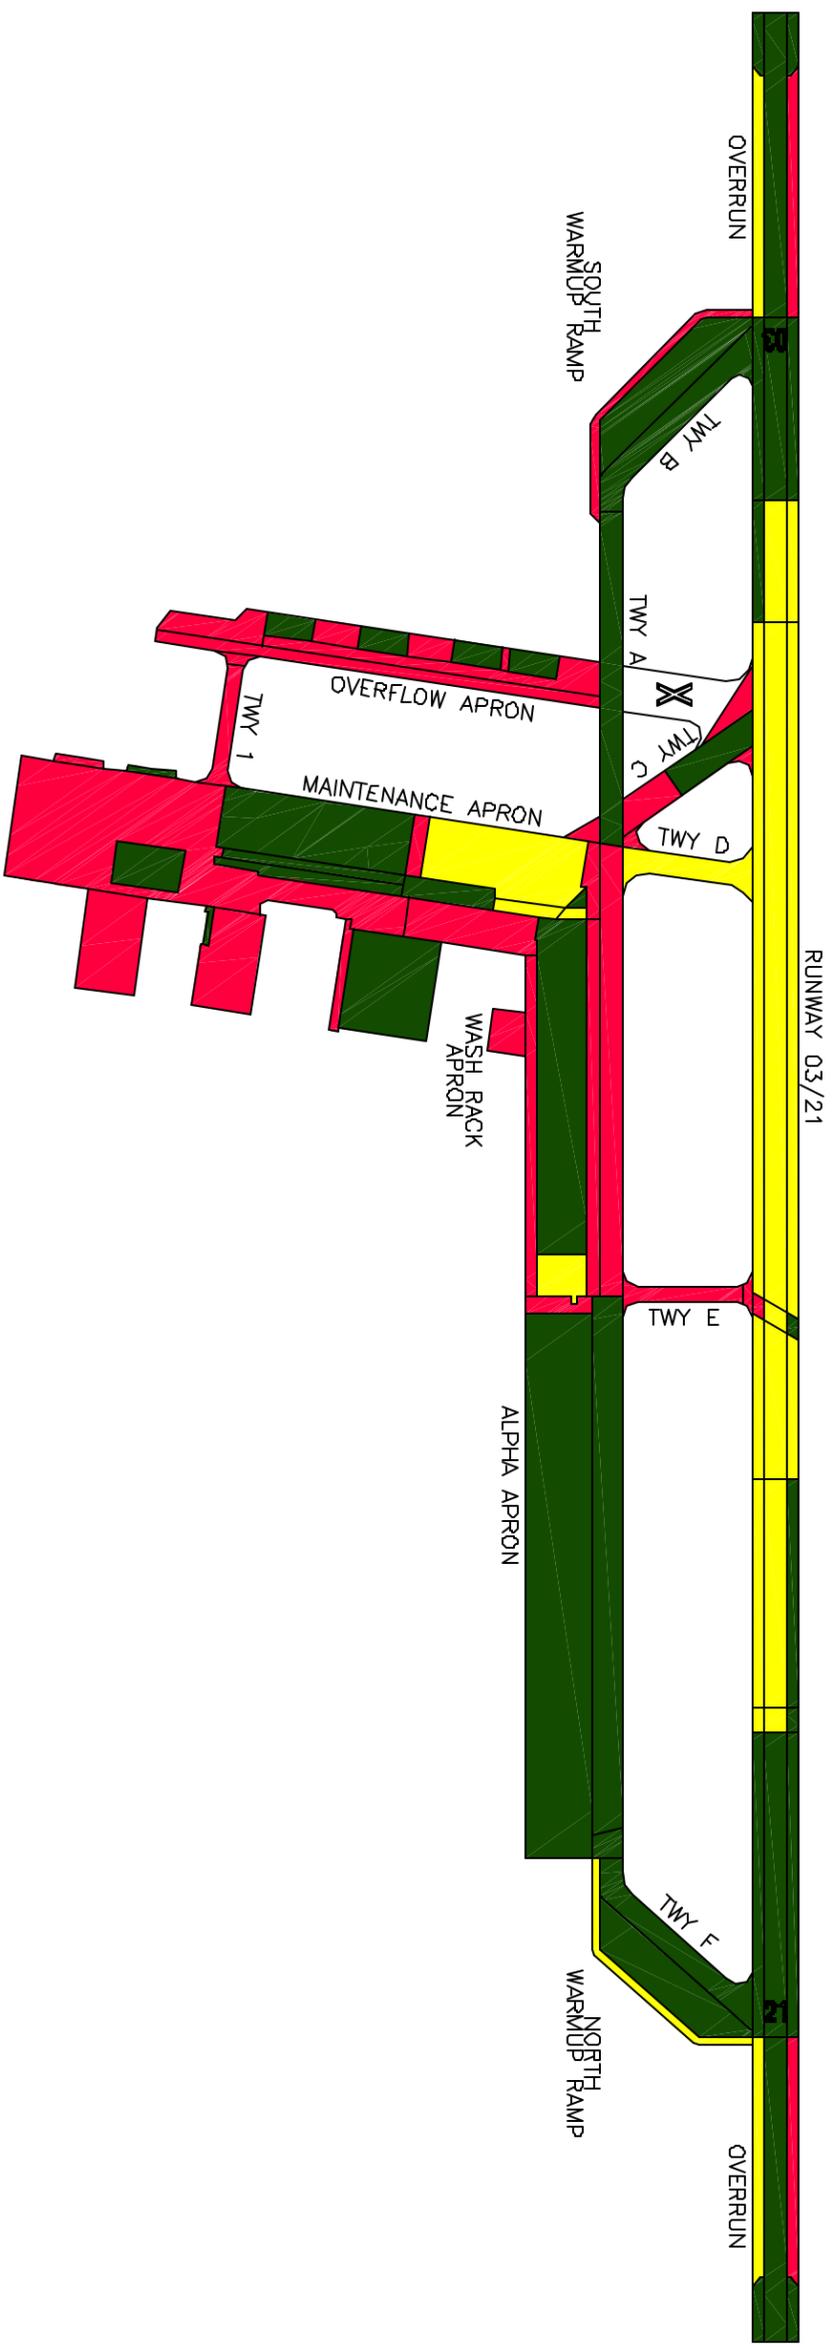
Figure 1. PCI Summary by Feature for Keesler Air Force Base Airfield Pavements.

Runway 03/21. The runway has a total area of 846,090, sq. ft. and an area weighted PCI of 70. The pavement condition survey indicates that 34% of the runway pavement has a PCI greater than 70, 36% has a PCI between 55 and 69, and 30% has a PCI of less than 55. The EA rating is Degraded due to moderate FOD potential and moderate skid/hydroplaning potential.

Taxiways. The taxiways have a total area of 699,101 sq. ft. and an area weighted PCI of 72. The pavement condition survey indicates that 59% of the taxiway pavements have a PCI greater than 70, 5% have a PCI between 55 and 69, and 36% have a PCI of less than 55. The EA rating is Degraded due to moderate FOD potential.

Aprons. The aprons have a total area of 1,999,861 sq. ft. and an area weighted PCI of 63. The pavement condition survey indicates that 59% of the apron pavements have a PCI of greater than 70, 3% have a PCI between 55 and 69, and 38% have a PCI less than 55. The EA rating is Degraded due to moderate FOD potential and moderate structural deficiency.

Shoulders. The shoulders have a total area of 47,975 sq. ft. and an area weighted PCI of 56. The pavement condition survey indicates that 100% of the shoulder pavements have a PCI between 40 and 65. The EA rating is Degraded due to moderate PCI deficiency.

Overruns. The overruns have a total area of 301,148 sq. ft. and an area weighted PCI of 79. The pavement condition survey indicates that 60% of the shoulder pavements have a PCI of greater than 70, 20% has a PCI between 55 and 69, and 20% have a PCI less than 55. The EA rating is Degraded due to moderate FOD potential.

Overall Airfield. The overall airfield has a total area of 3,894,174 sq. ft. and an area weighted PCI (excluding shoulders) of 67. The pavement condition survey indicates that 52% of the airfield pavements have a PCI greater than 70, 12% have a PCI between 55 and 69, and 35% have a PCI less than 55. The EA rating is Degraded due to moderate FOD potential and moderate structural deficiency.

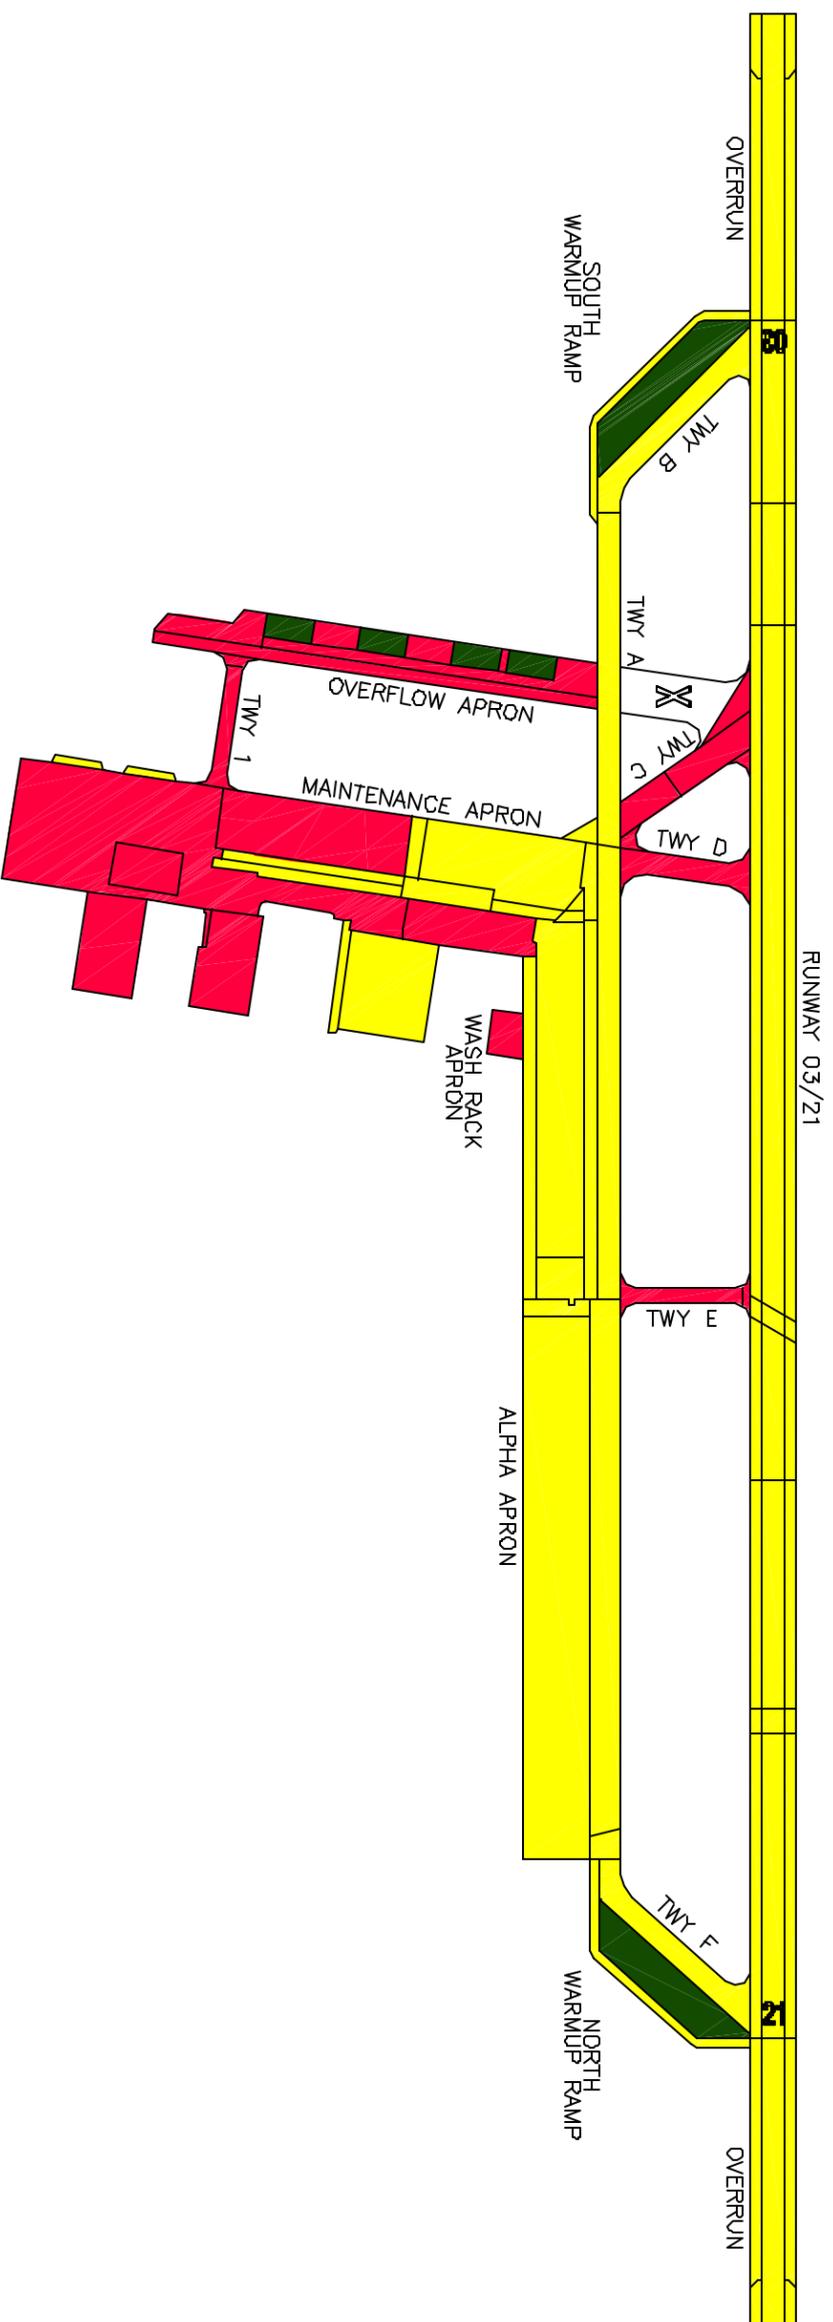
Figure 2. Engineering Assessment Rating by Facility for Keesler Air Force Base Airfield Pavements.

As indicated in Table 2, Taxiway “D” has an EA rating of unsatisfactory. The unsatisfactory EA rating is due to the ACN/PCN being greater than 1.50. In Tables 3 and 4 no M&R costs are indicated for Taxiway “D” M&R due to the PCI being greater than the critical PCI of 55; however, further analysis of the requirements to upgrade the structural deficiency may be warranted.

The area weighted averages of PCI, ACN/PCN, and FOD potential of the feature/sections of a facility are combined to produce the EA rating for each facility. The EA for the airfield facilities is shown in Table 2.
