AFCESA-APE-532

AIRFIELD PAVEMENT EVALUATION

**Keesler Air Force Base
Mississippi**

October 2000

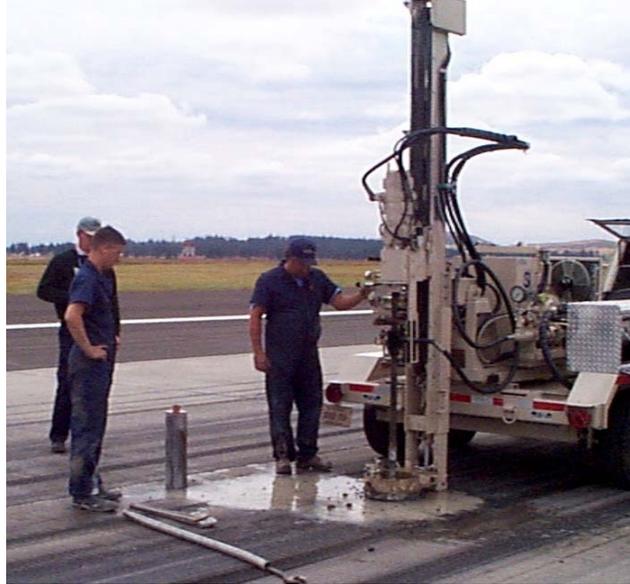
Figure 1-- Coring Operation

Figure 1 shows a typical coring operation. Six-inch diameter diamond-tipped coring barrels are used to cut through both asphaltic concrete (AC) and PCC pavements. This type of pavement coring system is capable of cutting through pavements to depths of approximately 36 inches.

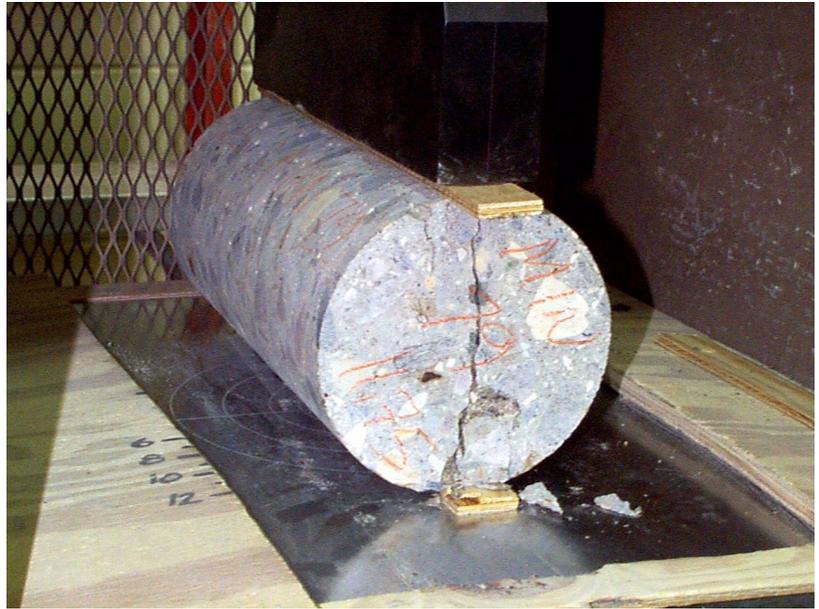
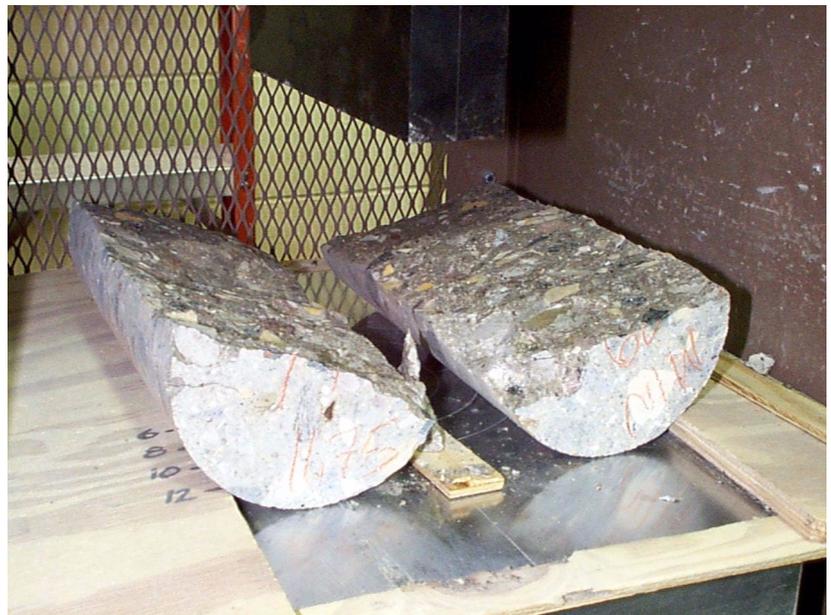
Figure 8--Split Tensile Test

The split tensile testing process provides an excellent opportunity to observe distresses internal to the PCC structure. If a concrete pavement is suffering from alkali-silica reaction (ASR), excessive air voids in the mix, or aggregate gradation/quality problems, these flaws will be observed as the concrete cores are split open. No notable defects were noted in those cores subjected to split tensile testing.

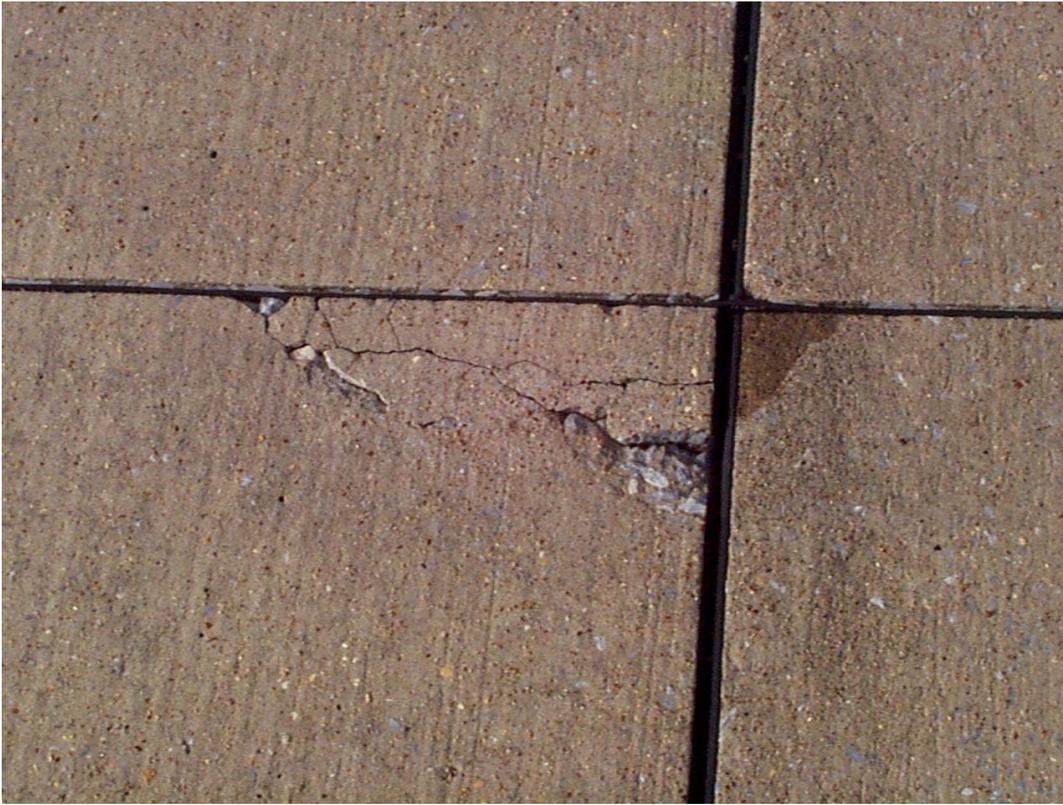
Figure 9--Runway Corner Spall

Spalling around the perimeter of the slabs, though at a low density, is the most common PCC distress. Figure 9 shows typical spalling and Figure 10 shows a distressed patch, which was originally placed to repair a corner spall.

1. **Runway PCC Pavement:** Execute minor repairs by patching the spalled areas and by replacing the failing patches. One transverse joint on the south overrun has opened up and needs to be re-sealed.
2. **Runway AC Pavement:** Mill and overlay the top 4" of the 75 foot keel of the interior and seal the cracks outside the interior keel and outside the overrun keel. Construct Feature R07C to greater strength
3. **Runway Storm Drain Depression:** In conjunction with the runway AC pavement reconstruction, material above and around the crossing large storm drain should be

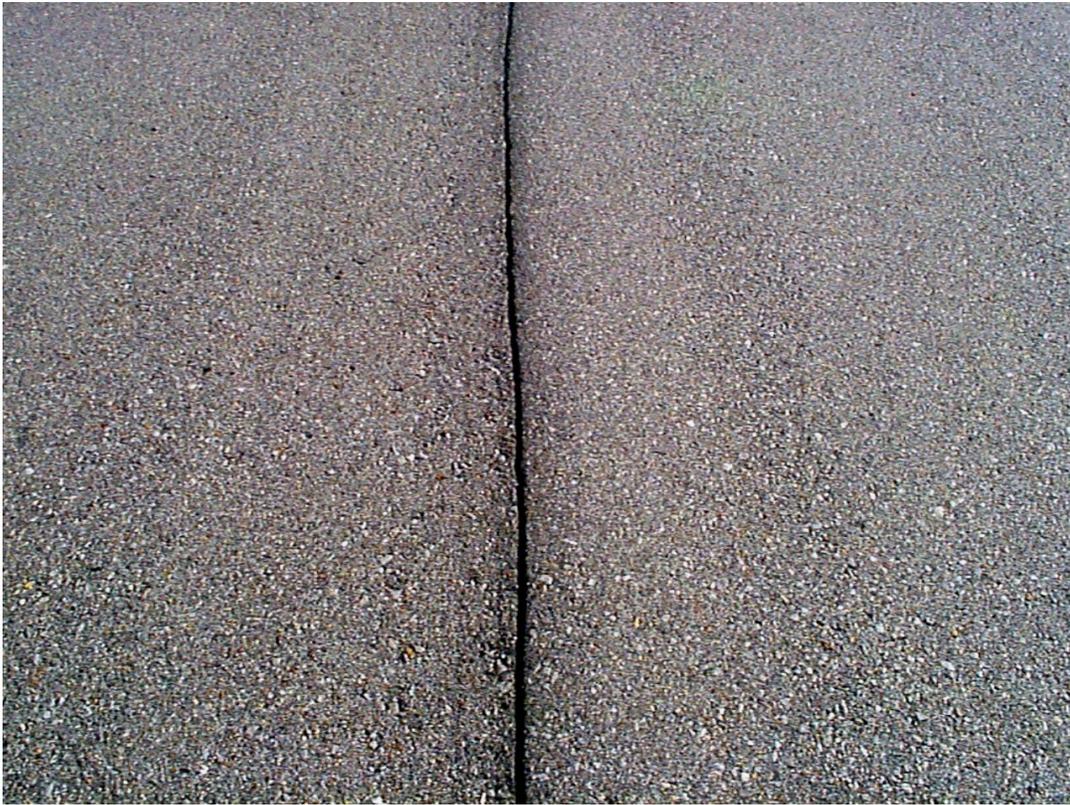
Figure 11--Runway AC Longitudinal Crack

As shown in Figure 11, longitudinal cracking following the seam between paving lanes have most significant distress. These cracks are generally in good condition and are not generating FOD. Some longitudinal cracks are classified as medium severity due to the unsealed crack width. Sealing these cracks would reduce the severity category to low because the infiltration of water would be prevented. Block cracking and raveling are also wide spread distresses, yet both are primarily of low severity. Block cracking on the runway is similar to that shown below in the discussion of the taxiways, but is not as advanced. Raveling is the weathering away of surface binder and aggregate. This distress is common to all the AC pavement at Keesler AFB due to age, but on the runway raveling is less severe than elsewhere on the airfield. Figure 12 shows the top section of an AC core sample taken over a longitudinal crack. This crack went through the full depth of the top 4 inches of the most recent overlay, but did not continue through the lower AC layers. Throughout most of the length of the runway interior, the total thickness of the AC is 9 inches or greater. Proper overlay repair would require milling down and replacing the top 4 inches.

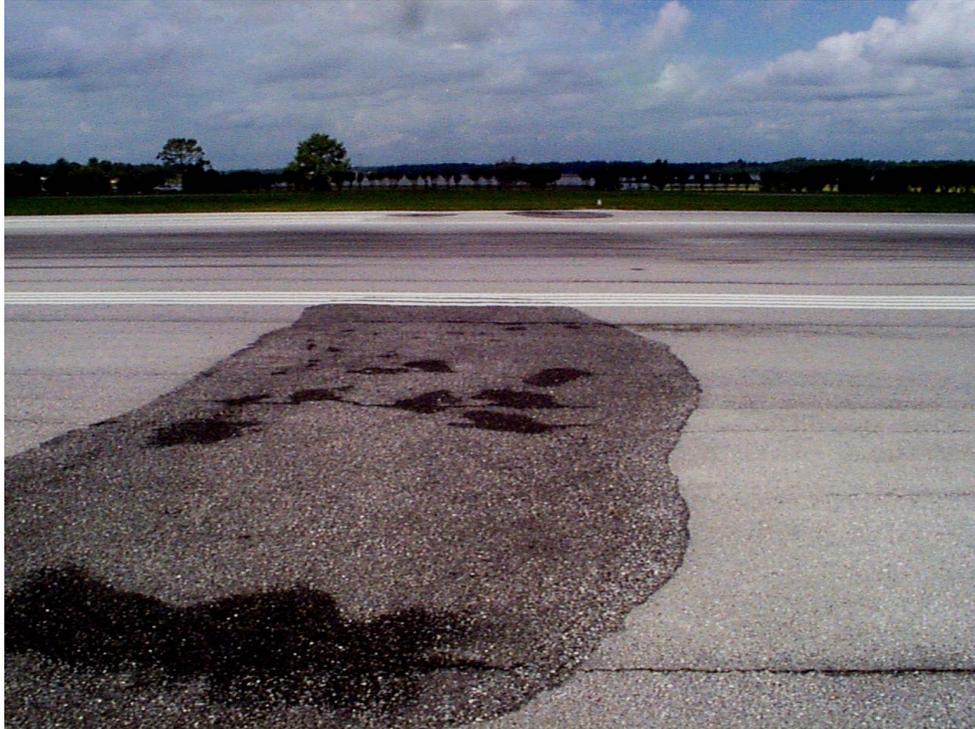
Figure 13--Subsidence on Runway

A large storm drain cross the airfield. It crosses the runway through Feature R07C. As shown in Figure 13, a wide depression (partially filled by patching) is present at this location. This most likely cause of this subsidence is the loss of subgrade material through joints or other openings of the storm drain.

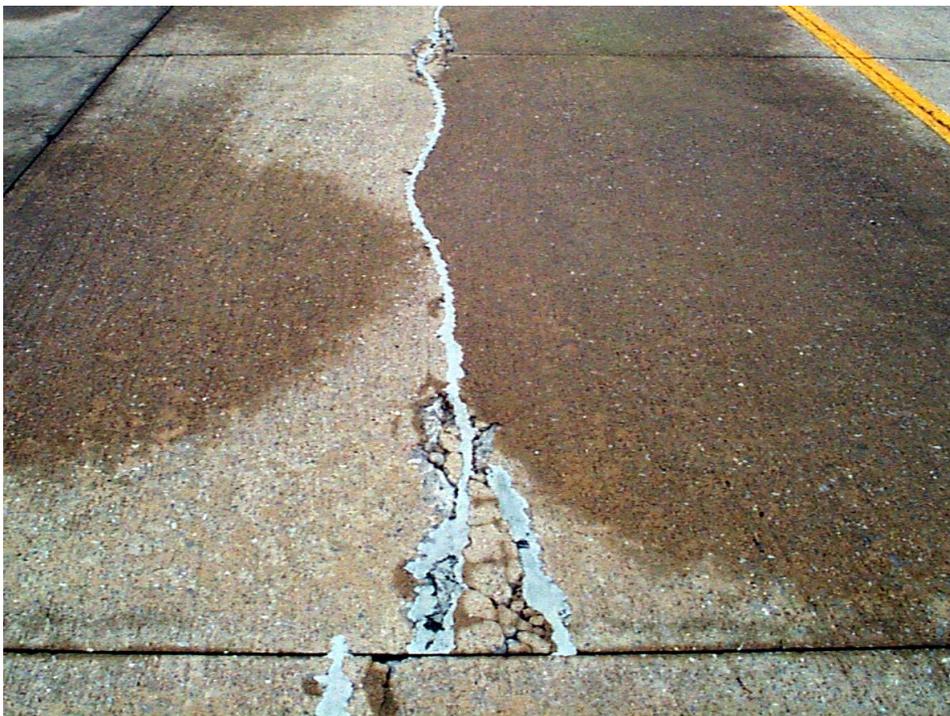
Figure 14--Taxiway "Alpha" Longitudinal Crack

Minor distresses common to the runway PCC pavement are present at a similar density within the taxiway PCC pavement. On the PCC portion of Taxiway "Alpha" (T01A) near Taxiway "Charlie", a significant number of slabs have longitudinal cracks. Many of these slabs have been replaced, and then subsequently cracks have formed in many of the replacement slabs. A Portland Cement (PC) stabilized sand-shell base is present directly beneath the PCC slab for all of the PCC construction of 1973. This stabilized material is high quality and in some respects has properties that resembles the rigid properties of PCC. Prior to the slab replacement, the crack in the original slab would have extended down through the stabilized base. The stabilized base appears to be the same under both the replacement and original slabs, and if in fact the stabilized base was not fully reconstructed with the replacement slab, the crack in the original stabilized base would reflect back up through the replacement slab. Figure 14 shows one of the more severe longitudinal cracks; Figure 15 shows a typical sample of PC stabilized base. Localized subsidence at the pavement edge above a storm drain was observed in this area (Figure 16); HWD response indicated that this subsidence may persist under the slabs.

5. **Taxiway “Charlie” (T03C):** Mill and overlay full depth of AC; certain areas require reconstruction of base material prior to overlay.
6. **Taxiway “Alpha” South (T01A):** Route and seal low severity cracks to prevent accelerated deterioration. Patch isolated points of higher distress and replace random slabs as condition requires. Keel replacement may be necessary 5 to 10 years in the future.

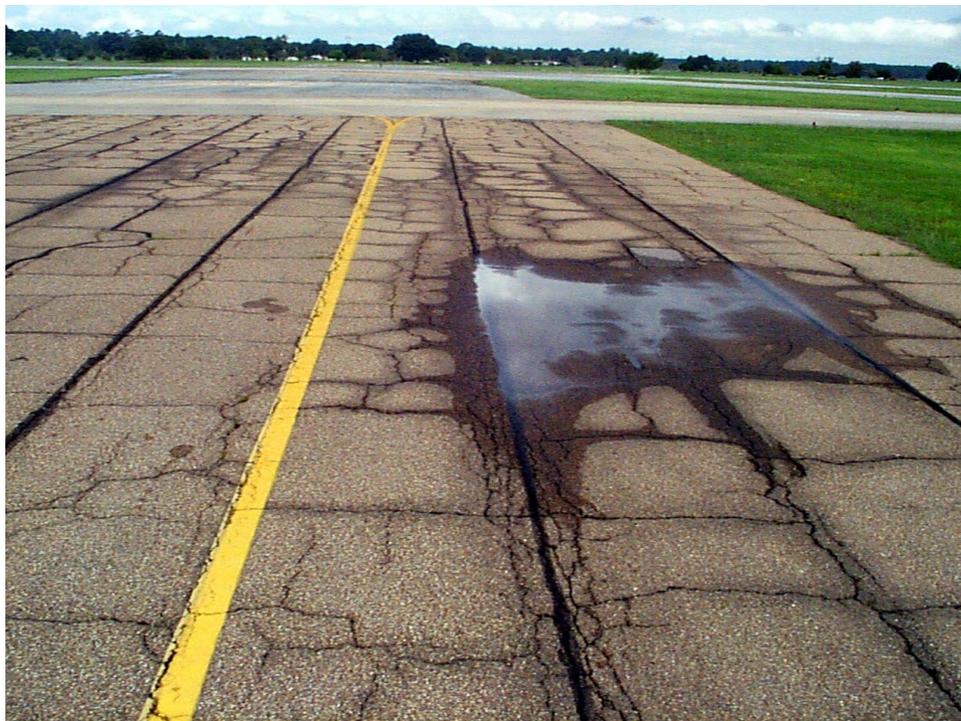
Figure 20--Overflow Apron Taxiway AC

The AC pavement comprising the overflow apron, Feature A02B, is in POOR condition. As with the features discussed above, this feature has distresses that are consistent with similar taxiway feature (T10C) previously discussed.
